FINAL—Archaeological Monitoring Report for Revegetation Efforts at the Hakioawa Watershed, Kaho‘olawe, Hawai‘i

TMK: (2) 2-1-001:001 (por.)

June 2015

Windy McElroy, PhD
and
Dietrix Duhaylonsod, BA

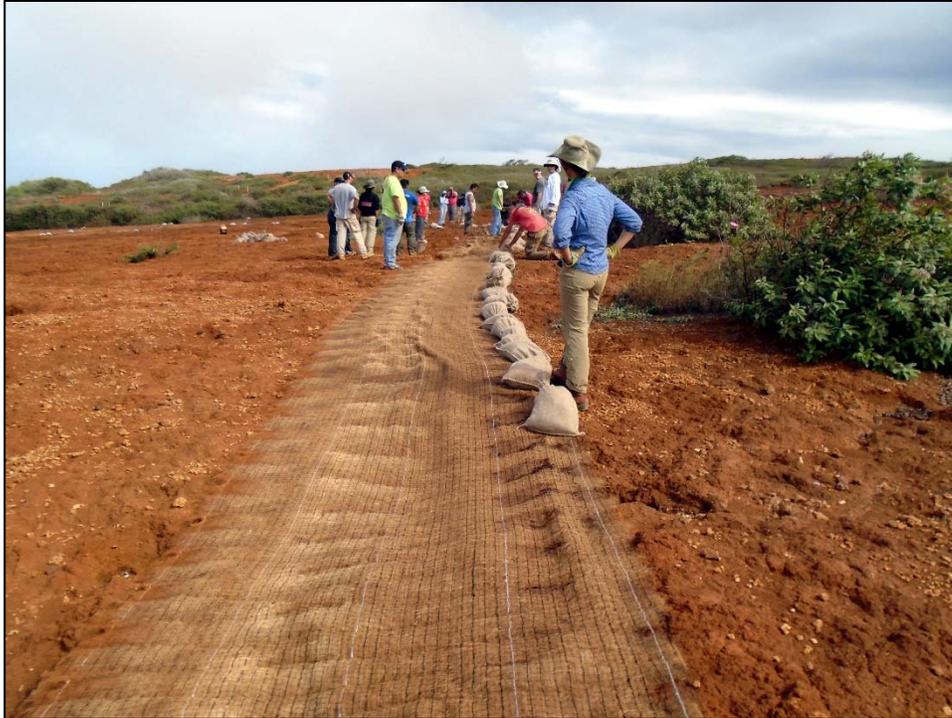
Figure 6. Volunteers extending the wattles at Site 704 to prevent artifacts from eroding downslope. View is to the east.

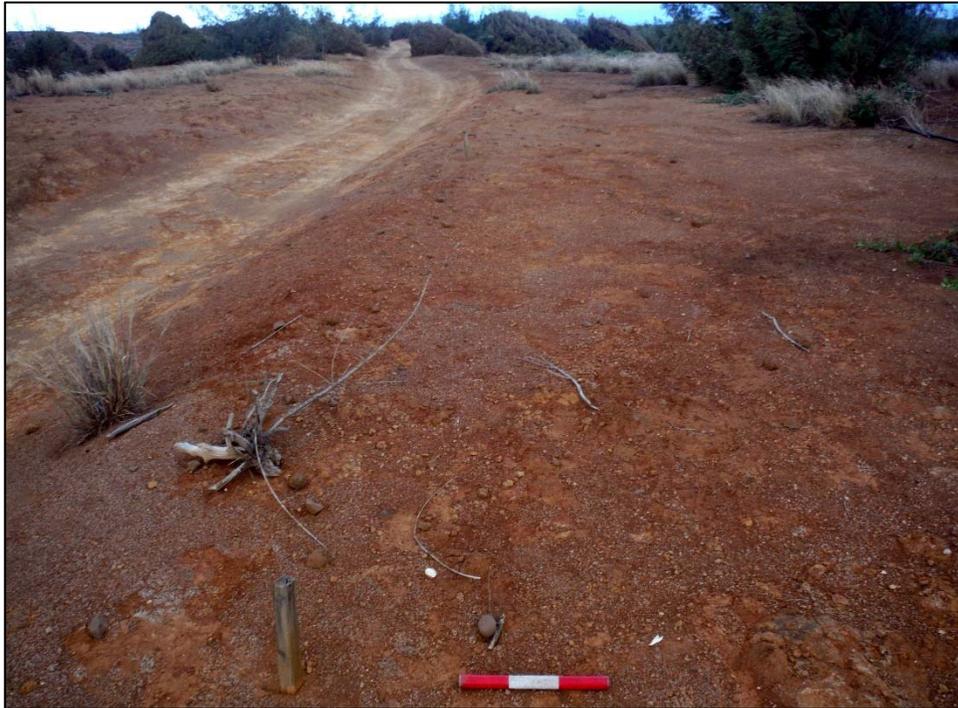
Feature H of Site 150 was not impacted by revegetation activity but is located near areas where revegetation efforts are occurring. Very scattered cultural material was noted on either side of the road (Figure 7).

Figure 7. Feature 150H, north side of the road, facing west. White pieces are marine shell, and a waterworn cobble is above the scale.

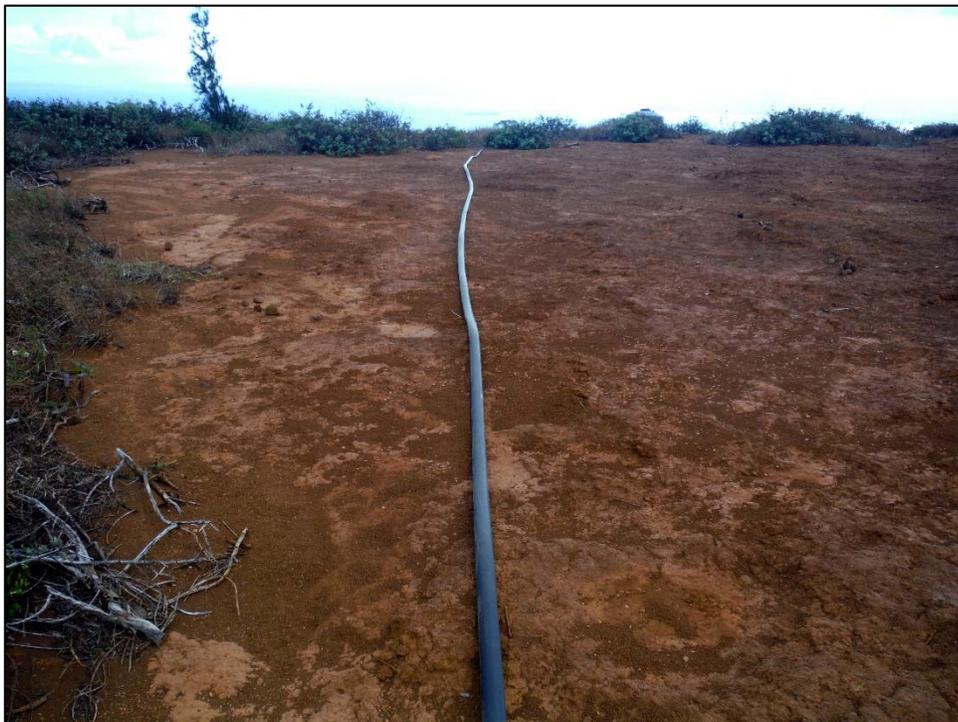
Figure 11. Feature 401H irrigation line on the west side of the feature, facing north. No cultural material is near the line, as it was moved to a safe location.

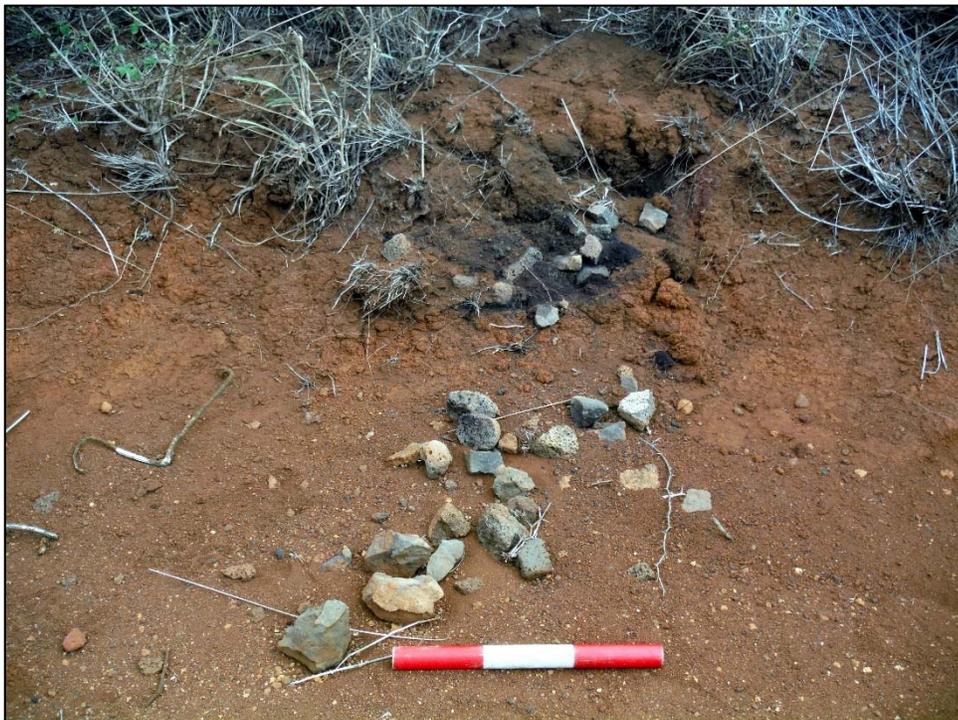
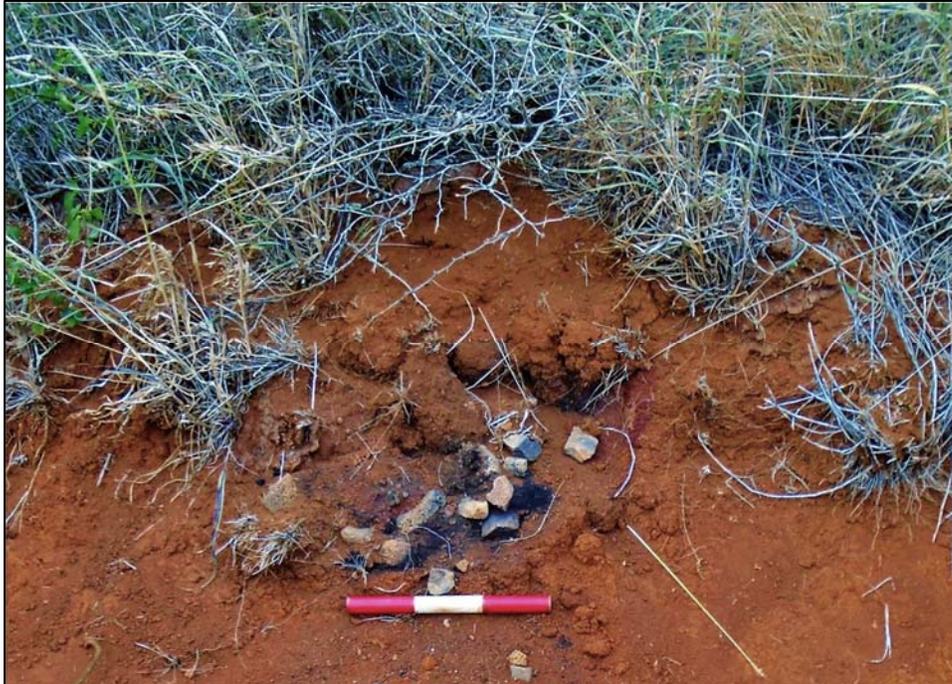
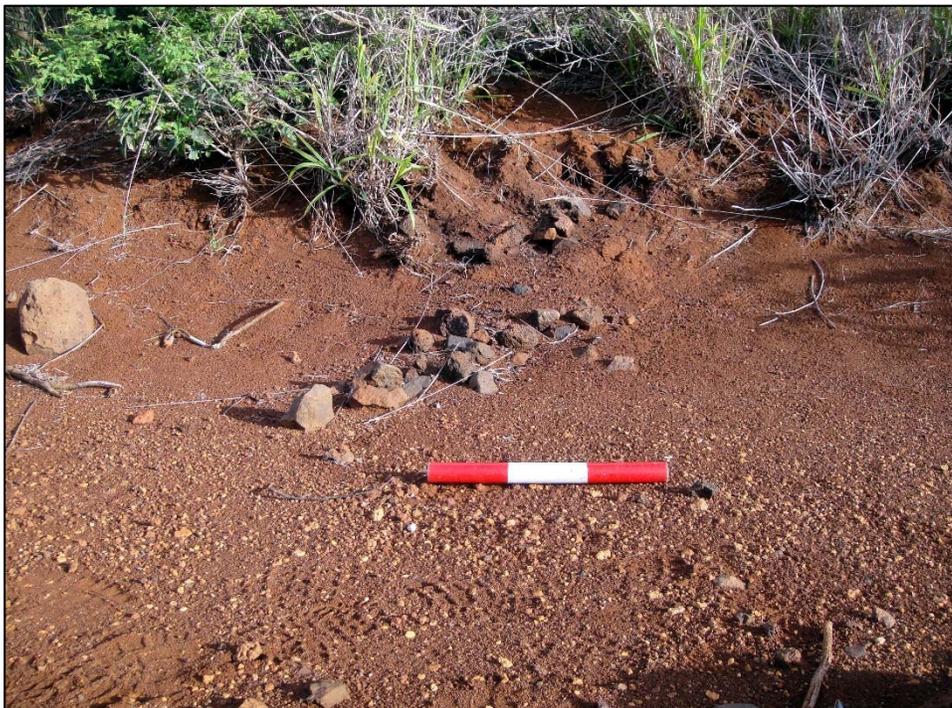
Figure 14. Fire feature at Site 473, facing north. Taken on August 20, 2014.

Figure 15. Fire feature at Site 473, facing north. Taken on October 15, 2014.

Figure 16. Fire feature at Site 473, facing north. Taken on February 11, 2015.

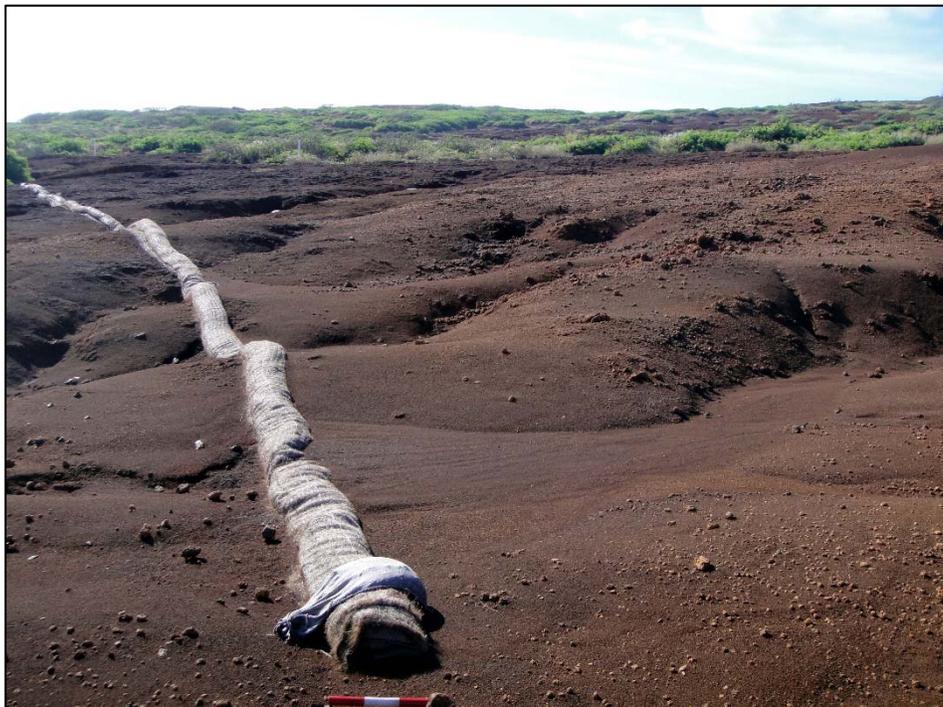
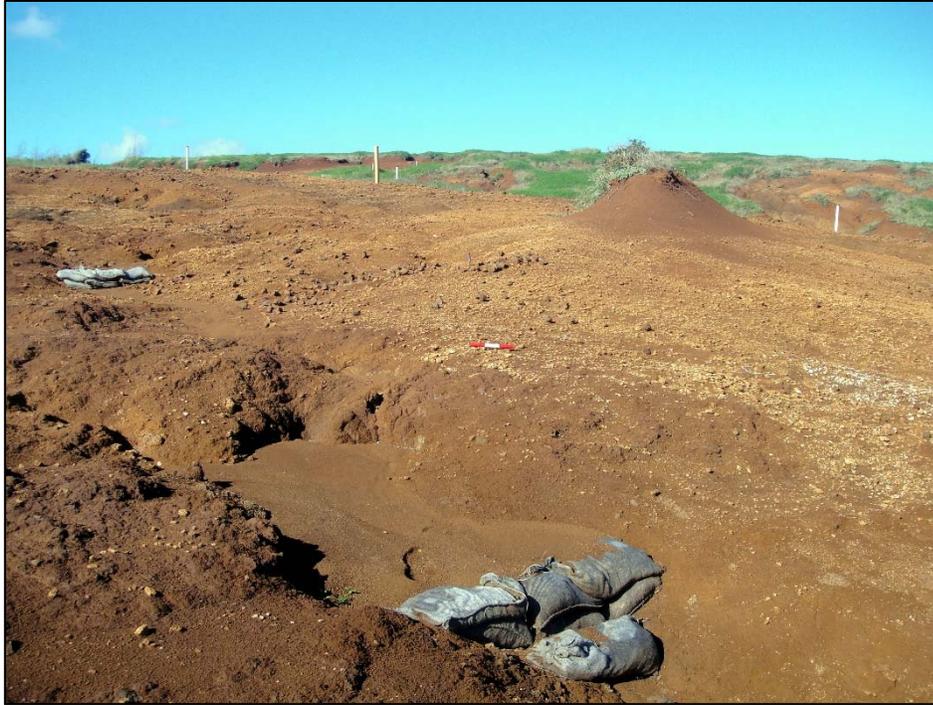
Site 520 consists of a fire pit and a scatter of fractured basalt, basalt flakes, volcanic glass flakes and cores, waterworn basalt cobbles, and shell midden. The cultural material scatter is relatively sparse and is eroding downslope outside the original boundaries of the site and into deep ravines on the north, west, and east. No revegetation efforts are being conducted near the site, and the erosion is occurring through natural processes. The fire pit was not found. Recommendations were made that the site should be protected by installing barriers along the ravines on the north, west, and east to capture cultural material before it is lost. Cultural material near the edges of the ravines were recommended for collection and placement toward the center or south side of the site, since context has already been lost due to erosion. Following the November 2014 site visit, wattles were placed near the edge of the cliff and sandbags positioned in the gullies. This was inspected during the February 2015 visit, and erosion has been noticeably curbed due to these efforts (Figures 20 and 21).

Figure 20. Site 520 erosion control measures implemented, facing southeast. Note the buildup of sediment on the upslope side of the barrier, indicating that erosion is being curbed.

Figure 21. Site 520 erosion control measures implemented, facing west. Note the buildup of sediment on the upslope side of the barrier, indicating that erosion is being curbed.

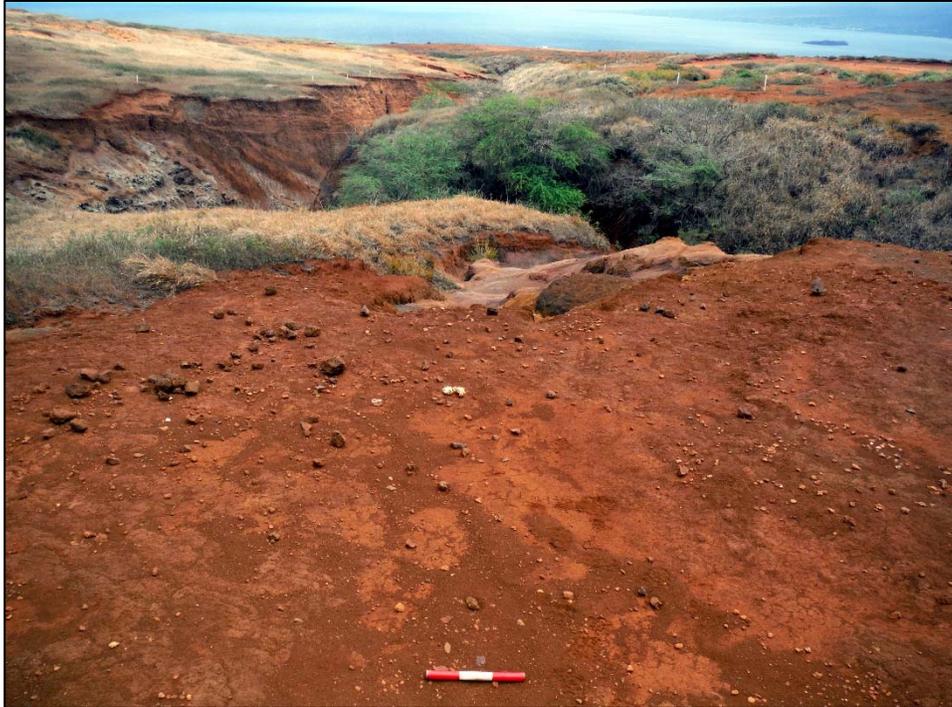
Figure 22. Feature 521B surface scatter eroding into the ravine. View is to the north.

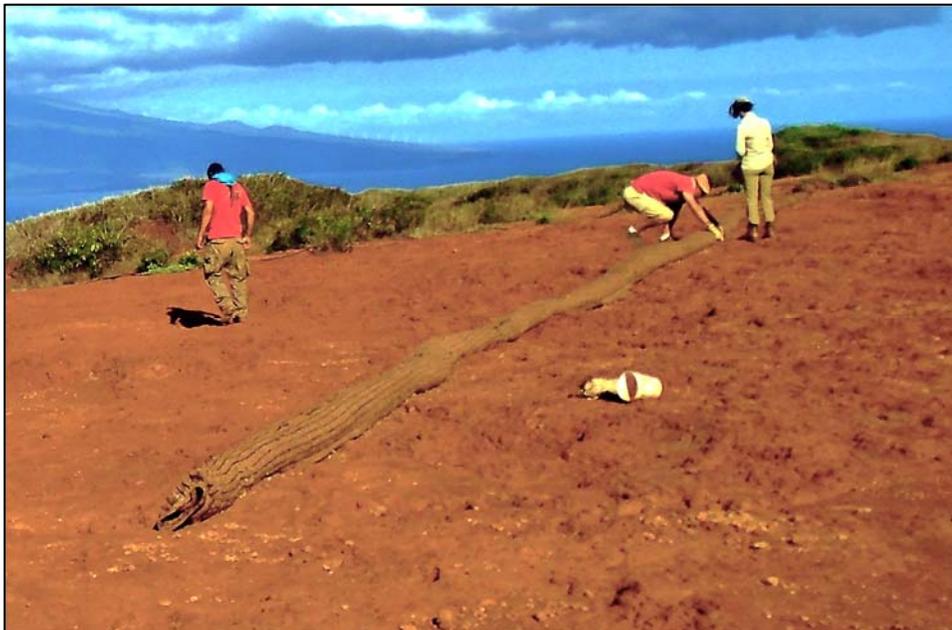
Three features, A–C, are described for Site 522, all scatters of cultural material. Feature A of Site 522 exhibits a moderate density of cultural material; Feature B a moderate to low density; and Feature C a low density. Cultural material is eroding down the slope due to natural processes. Revegetation activities are not impacting any of the features, however at Feature A an irrigation line is nearby but stops before entering the site. There are no irrigation lines near Features B or C. KIRC staff have demarcated the boundaries of all features with blue painted wood so that volunteers are cognizant of the boundaries. Cultural material is being washed downslope in heavy rain because of high levels of runoff on the hardpan in this area. It was recommended that wattles are installed upslope of Feature A, between Features A and B, between Features B and C, and downslope of Feature C. It was also recommended to place additional sandbags in the deep gullies along the hillside. These tasks were completed during the October 2014 site visit under the supervision of an archaeological monitor (Figure 23).

Figure 23. Construction of a wattle between Features 522A (right of wattle) and 522B (left of wattle). View is to the southeast.

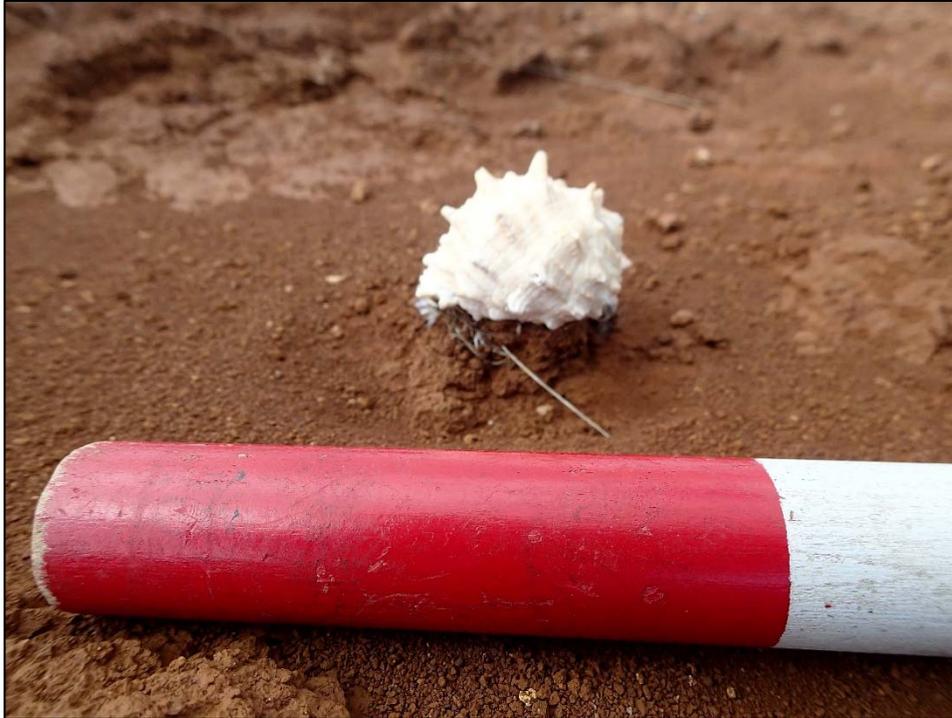
Figure 25. Marine shell on erosional pedestal at Feature 525C. View is to the west.

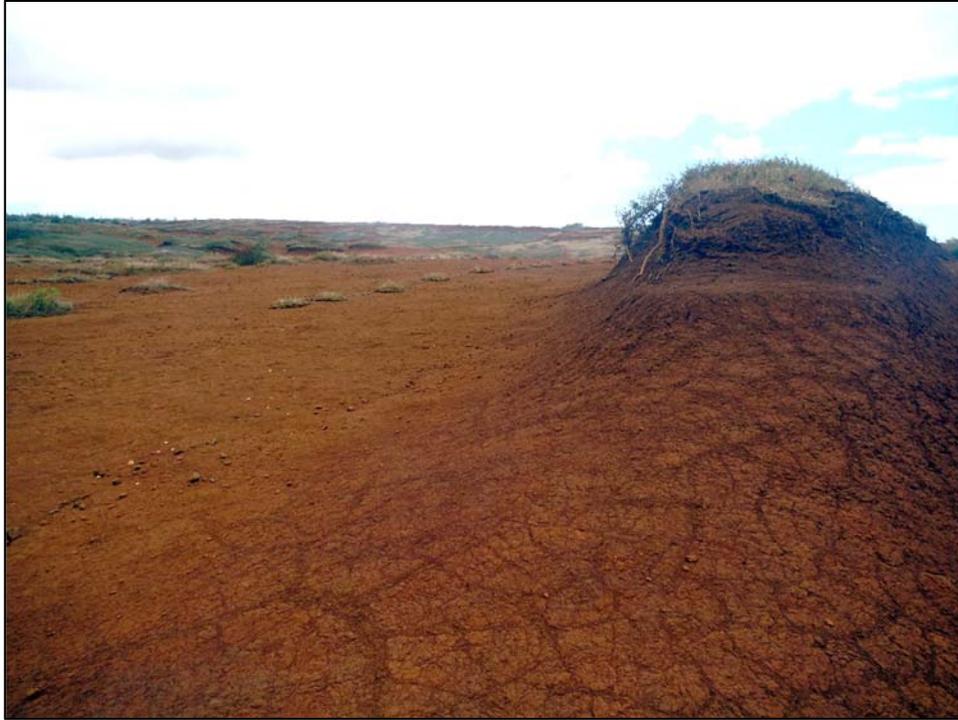
Figure 30. Site 526, facing southwest. Note the irrigation line with planting mounds in the distance.

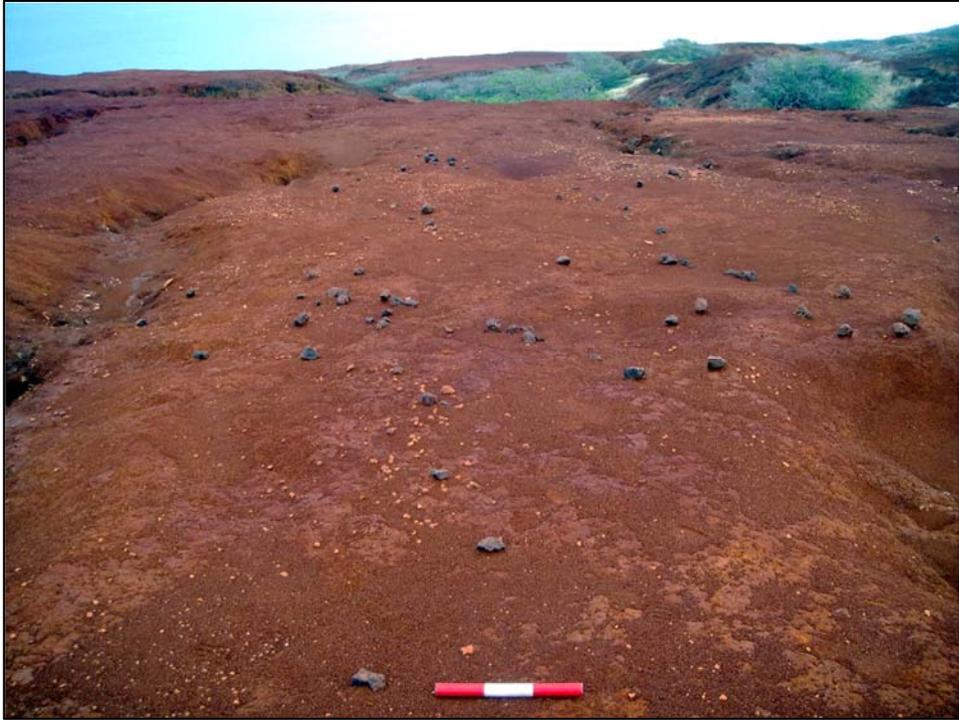
Figure 33 Site 538, showing erosional gullies and gulch in the distance. Orientation is to the northeast.

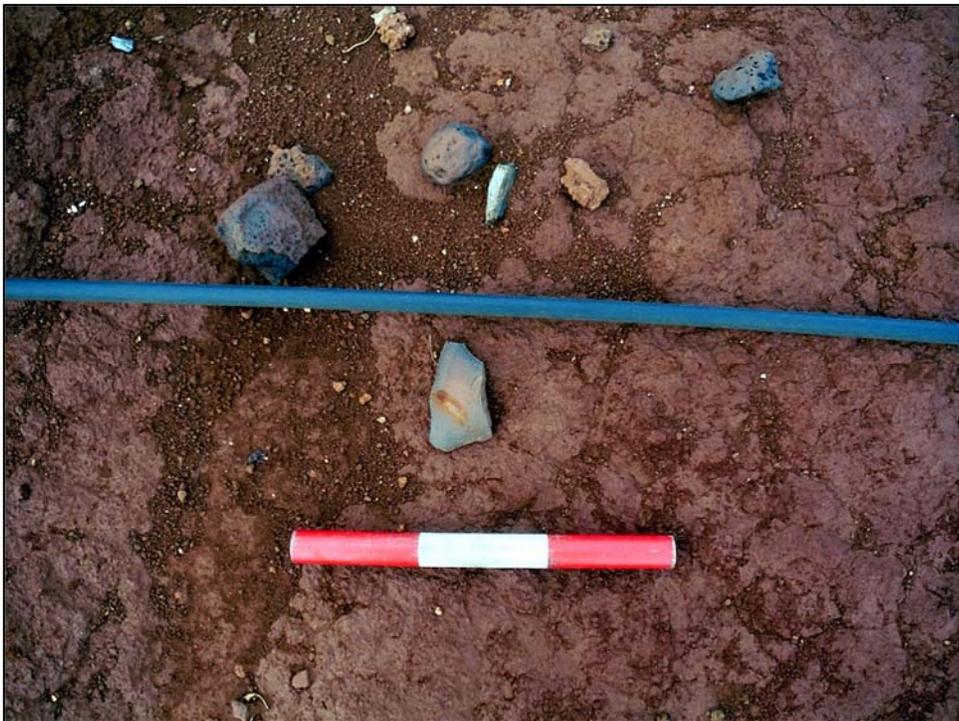
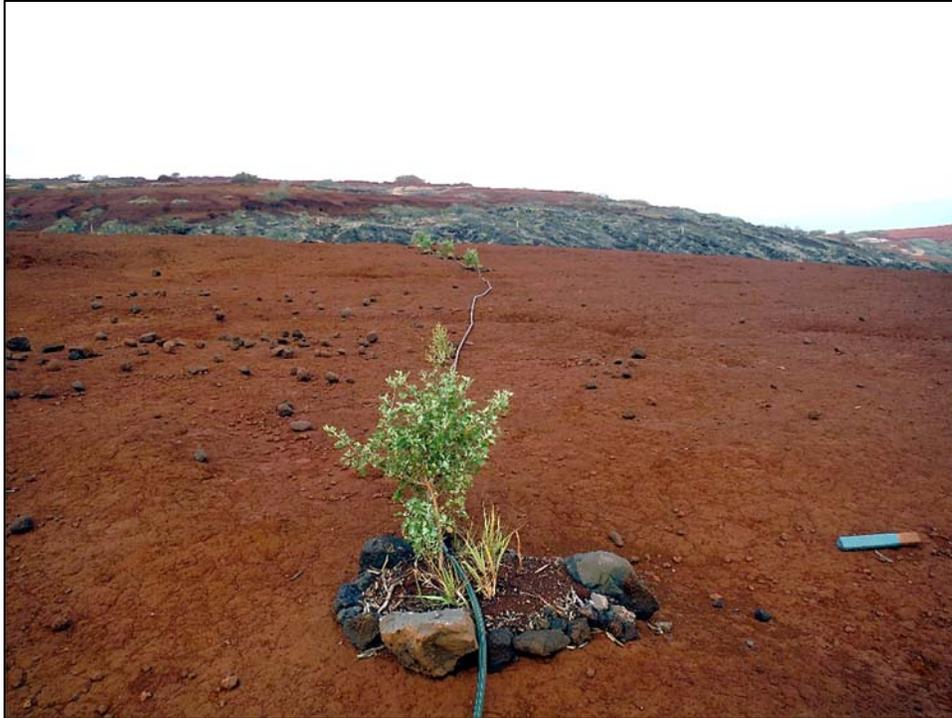
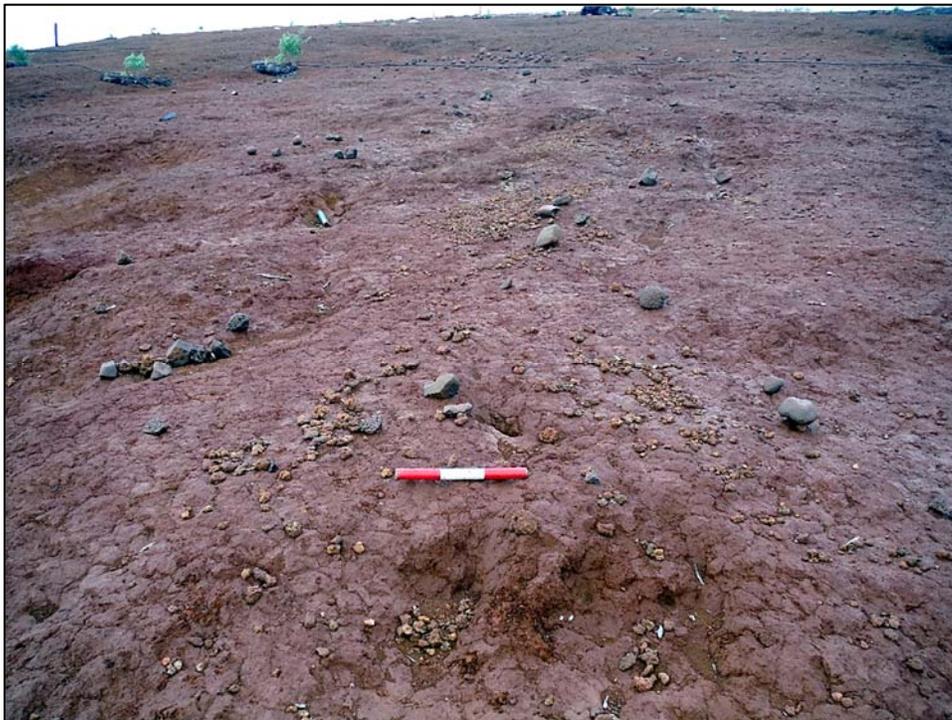
Two features of this site, 539A and B are described for the project area, both scatters of cultural material. Feature 539A was observed as a fairly dense scatter of cultural material. On the south side of the feature, an irrigation line with no planting mounds runs through the site. KIRC staff moved cultural material away from the path of the line before it was installed, although some was missed (Figure 34). On the north side of the feature, an irrigation line with planting mounds cuts through the site (Figure 35). No cultural material was observed along this northern line. The feature boundaries are demarcated with blue wooden pieces, although cultural material was observed very close to these boundaries (Figure 36). It is recommended that the wooden markers are moved further away from the feature to encompass a larger area.

Figure 34. Basalt flake along the southern irrigation line at Feature 539A, plan view.

Figure 35. Northern irrigation line and planting mound that run through Feature 539A.

Figure 36. Northern portion of Feature 539A, facing south. Note the lithic material just beyond the scale, the blue wood pieces that demarcate the feature boundaries, and the irrigation line and planting mounds in the distance.

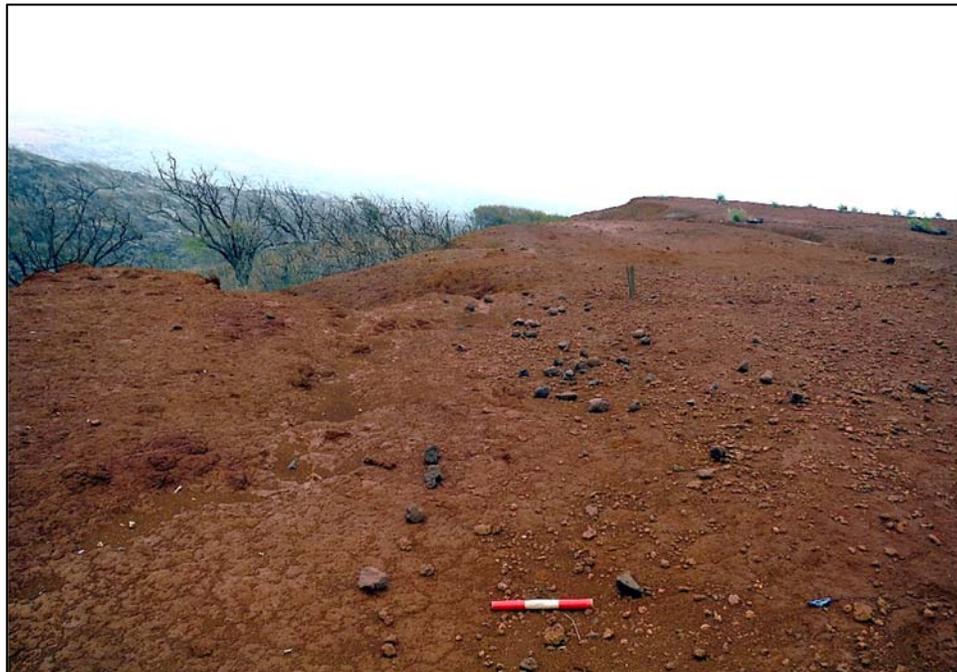
Feature 539B was observed as a small scatter of sparse cultural material. The feature is close to a ravine and cultural material may be eroding downslope (Figure 37). The feature boundaries are marked in blue wood pieces, and irrigation lines were placed upslope, away from the feature. It is recommended that barriers are installed along the edge of the ravine on the north to capture cultural material before it is lost. Cultural material near the edges of the ravine may also be collected and placed in a safe location within the site, since context has already been lost due to erosion.

Figure 37. Feature 539B, facing north.

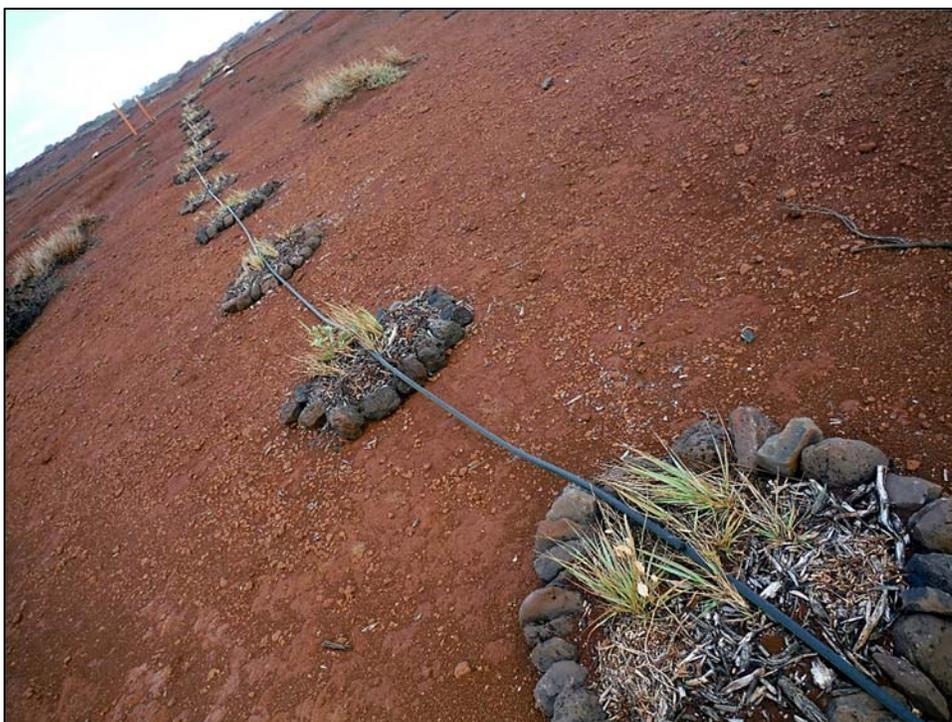
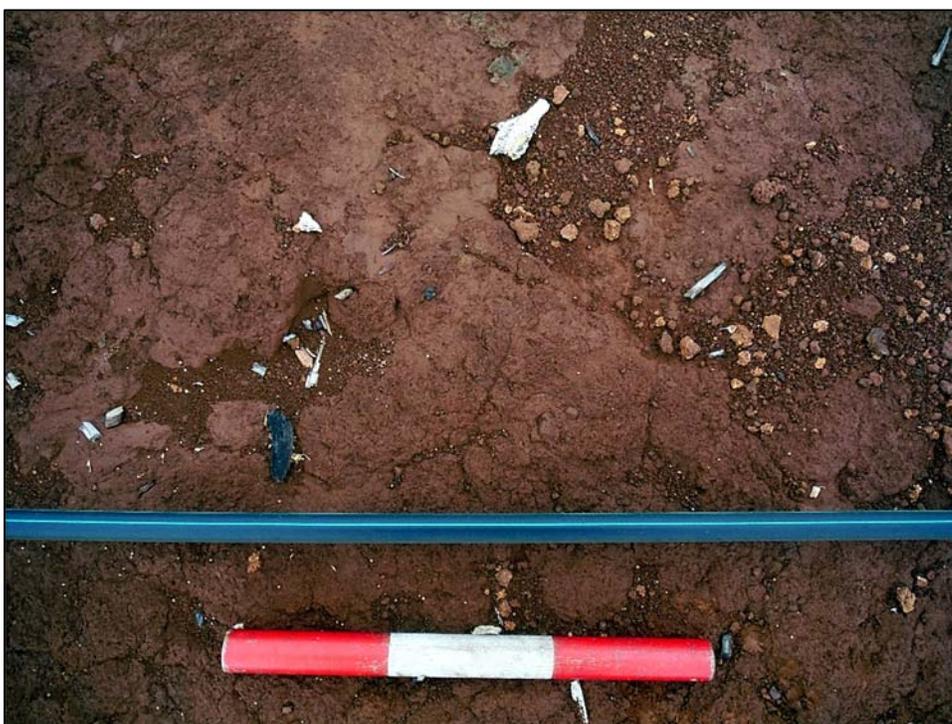
Feature C of Site 542 consists of a scatter of artifacts, fractured rock, basalt flakes and cores, volcanic glass flakes and cores, coral fragments, and shell midden. Feature C covers a large area but is not particularly dense with cultural material. Two irrigation lines with planting mounds run through the feature (Figure 38). A few artifacts are close to the lines, but the only damage observed was a broken piece of coral (Figure 39). It is possible, however, that the mounds were placed atop cultural material that is now obscured. It is recommended that site locations and their boundaries are clearly conveyed to the field crews so that cultural resources are not disturbed during future revegetation efforts.

Figure 38. Irrigation line and planting mound running through the center of Feature 542C. Orientation is to the west.

Figure 39. Disrupted coral at Feature 542C near an irrigation line, plan view.

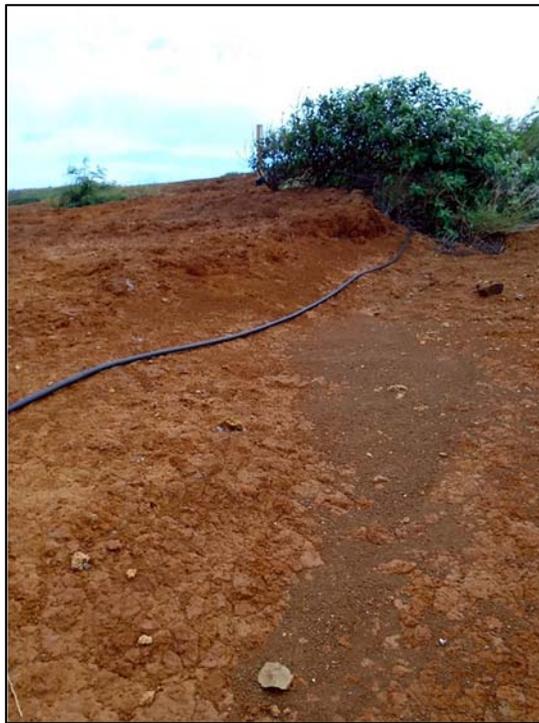
Figure 40. Basalt flake near irrigation line at Site 704, facing south.

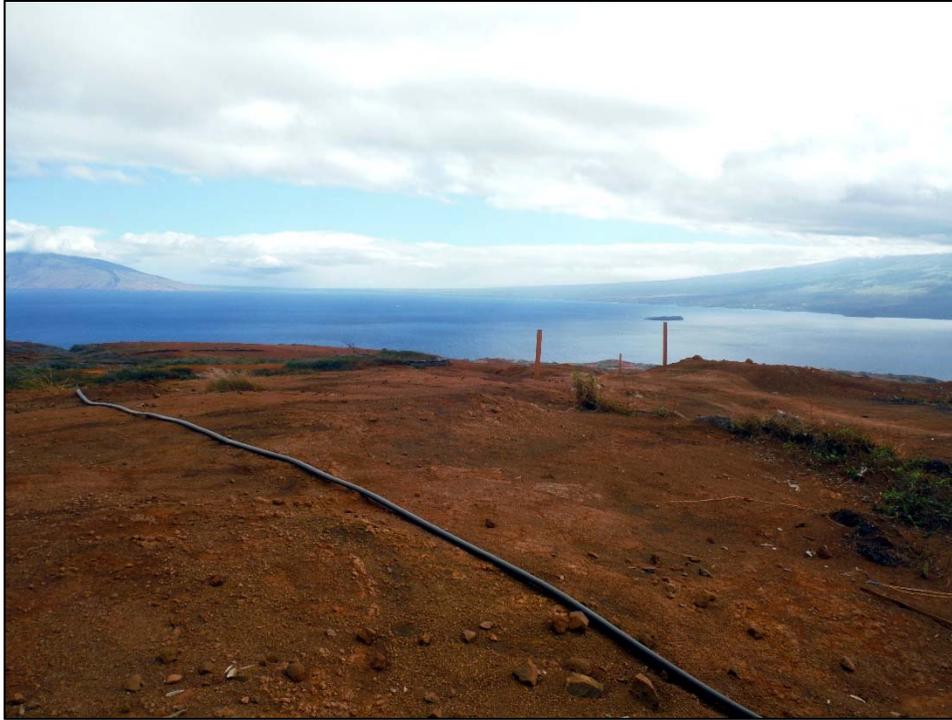
Figure 41. Irrigation line at Site 707, facing northeast.

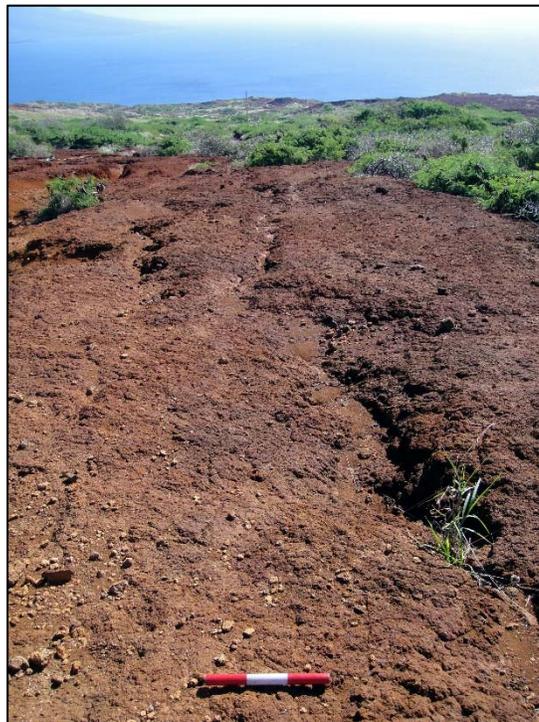
Site 734 is a scatter of artifacts, fractured basalt, basalt flakes, basalt cores, and shell midden. It currently consists of a low to medium density scatter. The site is not being affected by vegetation activity but is eroding naturally downslope (Figure 42). Wattles or sandbags may help control the erosion.

Figure 42 Site 734, showing erosional gullies. Orientation is to the east.

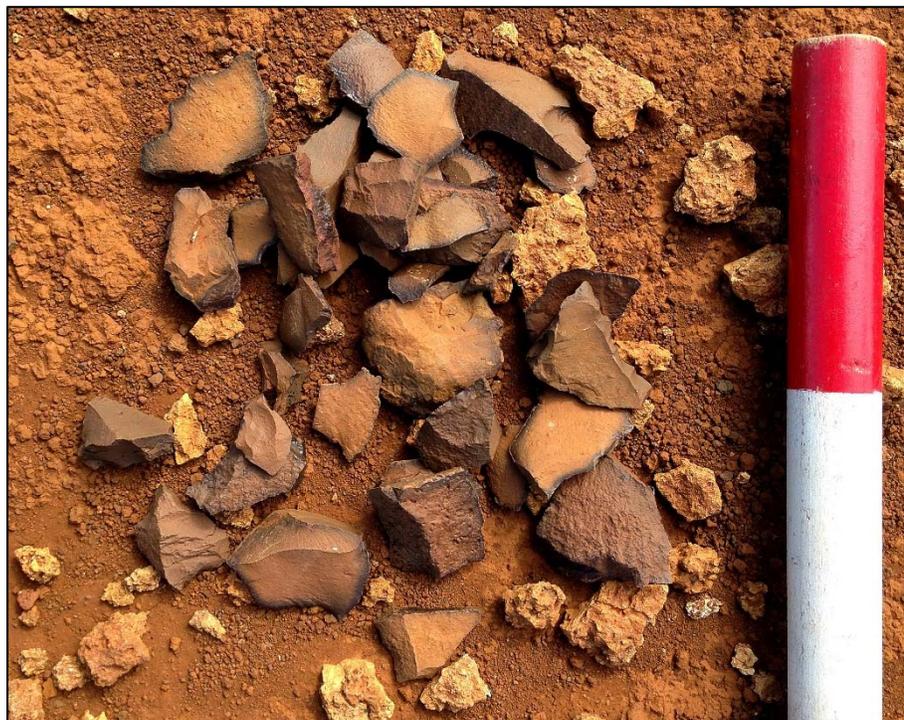
Site 888 is a scatter of artifacts, fractured basalt, basalt flakes, volcanic glass flakes, and volcanic glass cores. The site is currently sparsely scattered with cultural material. Its boundaries are marked with blue wooden pieces. Revegetation activity is not impacting the site, however natural erosion may be washing material downslope. Several basalt flakes were found in and adjacent to the planting corridor west of Site 888. The flakes were collected and relocated approximately 2 m upslope to within the site boundaries. The flakes were left in a pile to denote their artificial context (Figure 45). It is recommended that wattles are placed downslope of the site to help contain its material.

Figure 45. Basalt flakes relocated to Site 888, plan view.

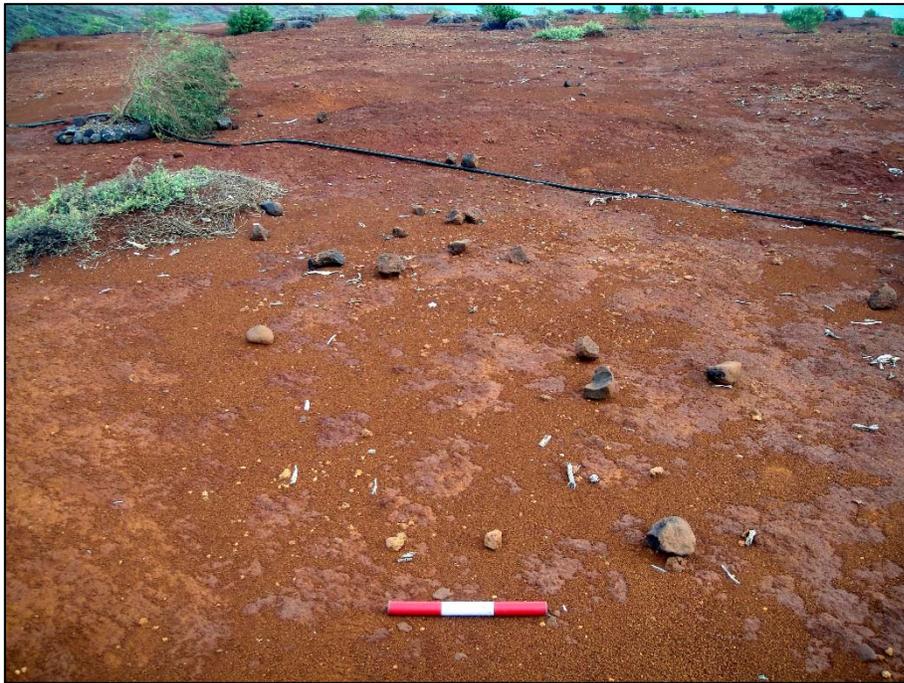
IF 40 was not assigned a site number because it is an isolated surface find, or individual find (IF). IF 40 was depicted just south of Feature 539B in a site map in the archaeological monitoring plan (KIRC 2013:9) and in an earlier report (Hammatt et al. 2001). No published data was found for the artifact and exactly what it is remains undetermined. Several attempts were made to locate the item during the site visits, and a small scatter of fractured basalt was found in the area where IF 40 should be. The scatter consists of roughly 20 cobbles. It is not certain if this is in fact IF 40, however, as no flakes, cores, or other more readily identifiable artifacts were found. It is possible that the fractured cobbles came from one of the planting mounds nearby (Figure 46). Given the uncertainty for identification of this site, impacts cannot be determined and recommendations cannot be made.

Figure 46. Fractured basalt cobbles that may or may not be part of IF 40, with planting mound in the distance. Orientation is to the west.
