FINAL—Archaeological Monitoring Report for Revegetation Efforts at the Hakioawa Watershed, Kaho‘olawe, Hawai‘i

TMK: (2) 2-1-001:001 (por.)

June 2015

Windy McElroy, PhD
and
Dietrix Duhaylonsod, BA

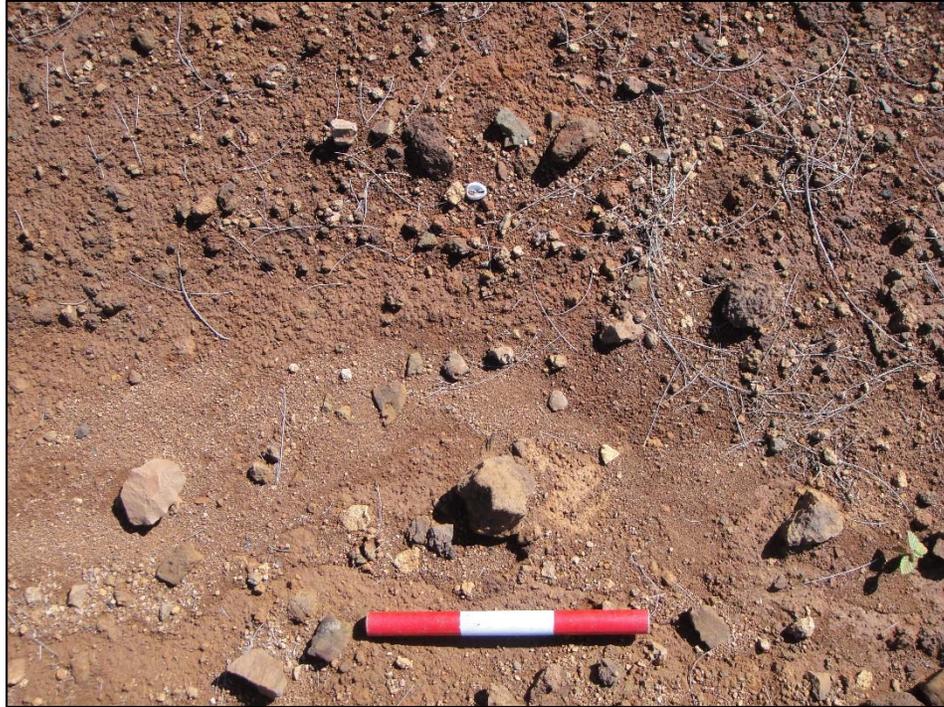
A total of seven features of this site, 401E–K, are described for the Hakioawa project area, all surface scatters of cultural material. Features E and I are not being impacted by vegetation efforts but are located nearby. They all consist of very sparse surface material (e.g., Figure 8). Feature F is also not being impacted but is nearby revegetation activity areas. This feature consists of sparsely to moderately scattered cultural material (Figure 9).

Figure 8. Feature 401E, plan view. Marine shell and lithic material are shown.

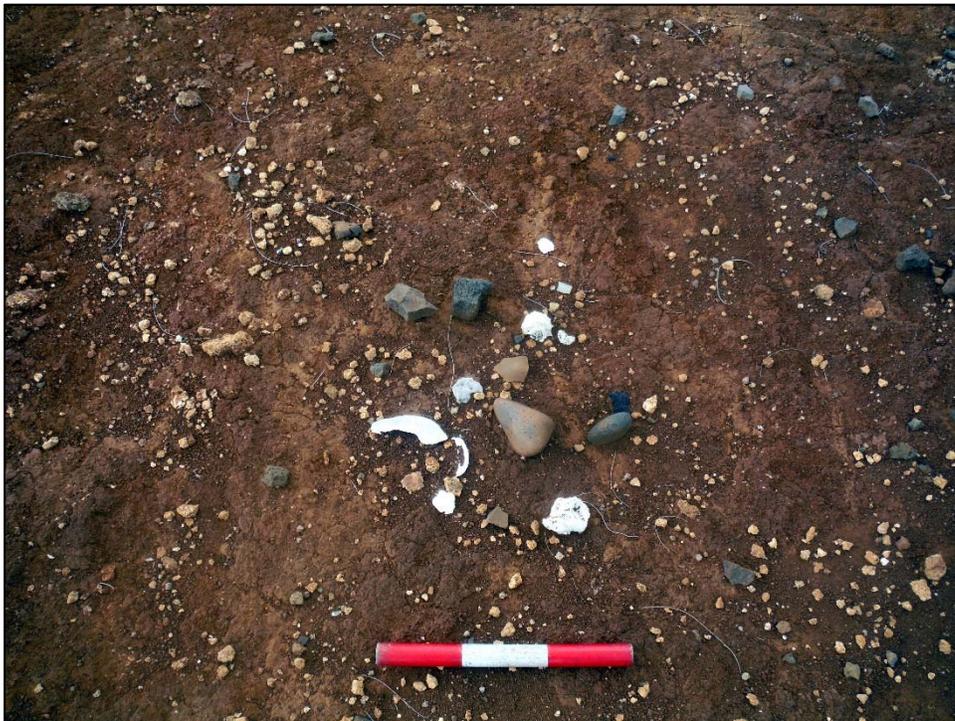
Figure 9. Feature 401F cultural material, facing southeast.

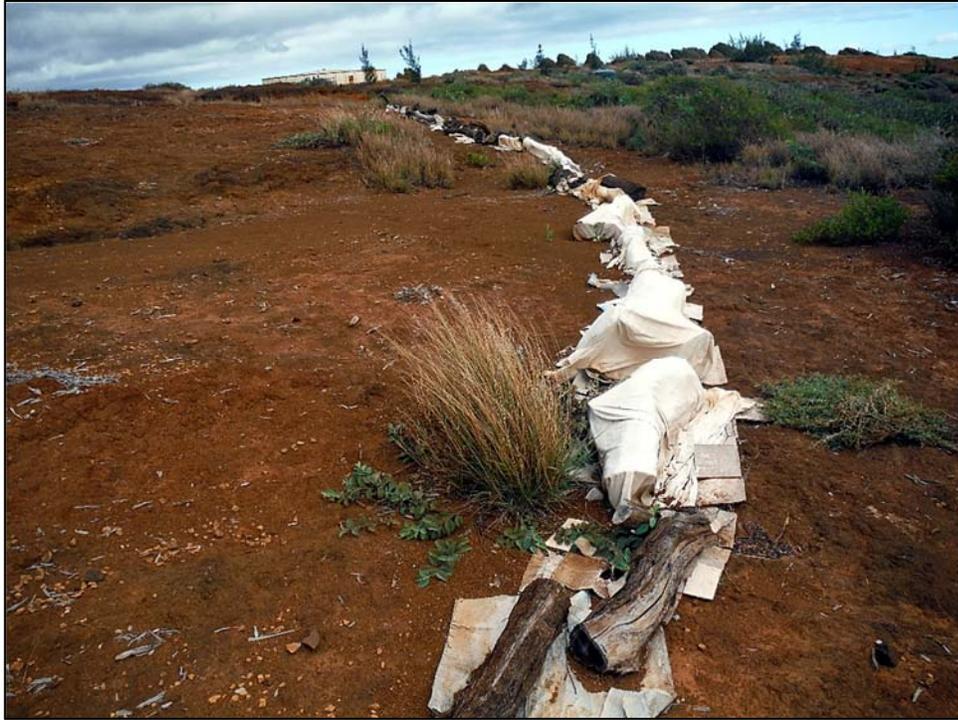
Feature 401G is outside the area currently being revegetated, although irrigation lines from a previous undertaking run through the feature and swales made of *kiawe* branches wrapped in sheets are nearby (Figure 10). Sparse cultural material was observed at the site.

Figure 10. Feature 401G *kiawe* swales, facing west.

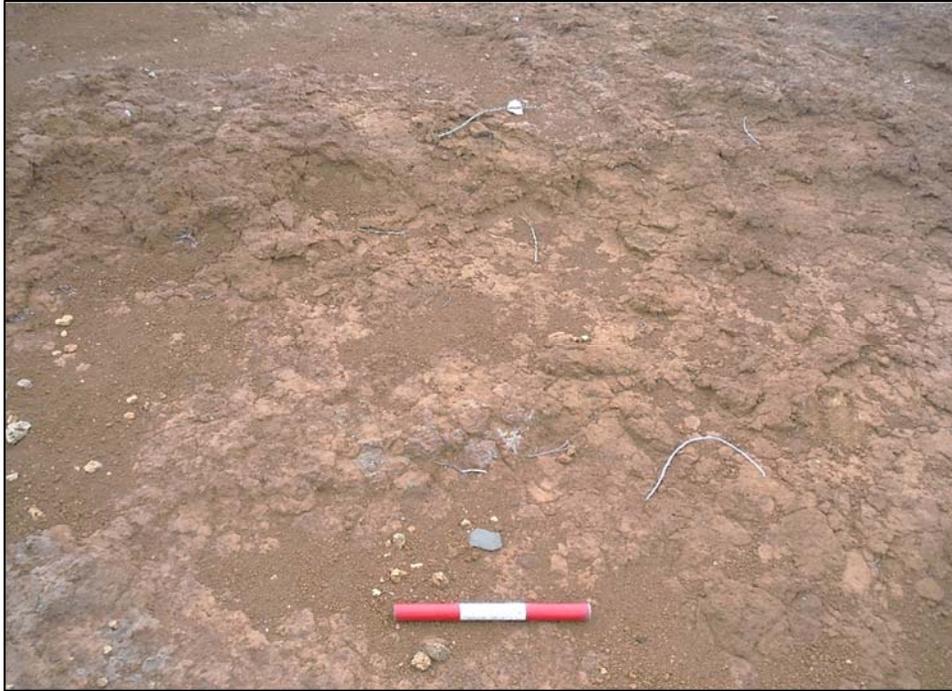
Figure 12. Feature 402A, facing southeast. A basalt flake is in the foreground and marine shell midden can be seen in the background.

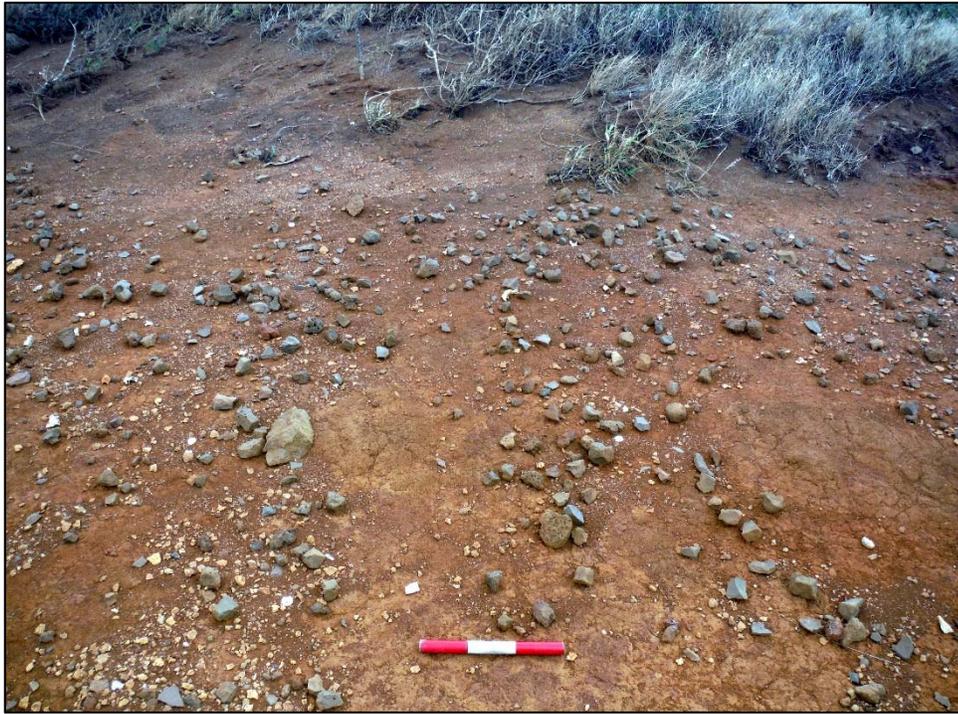
Figure 13. Dense scatter of cultural material at Site 473, facing southwest.

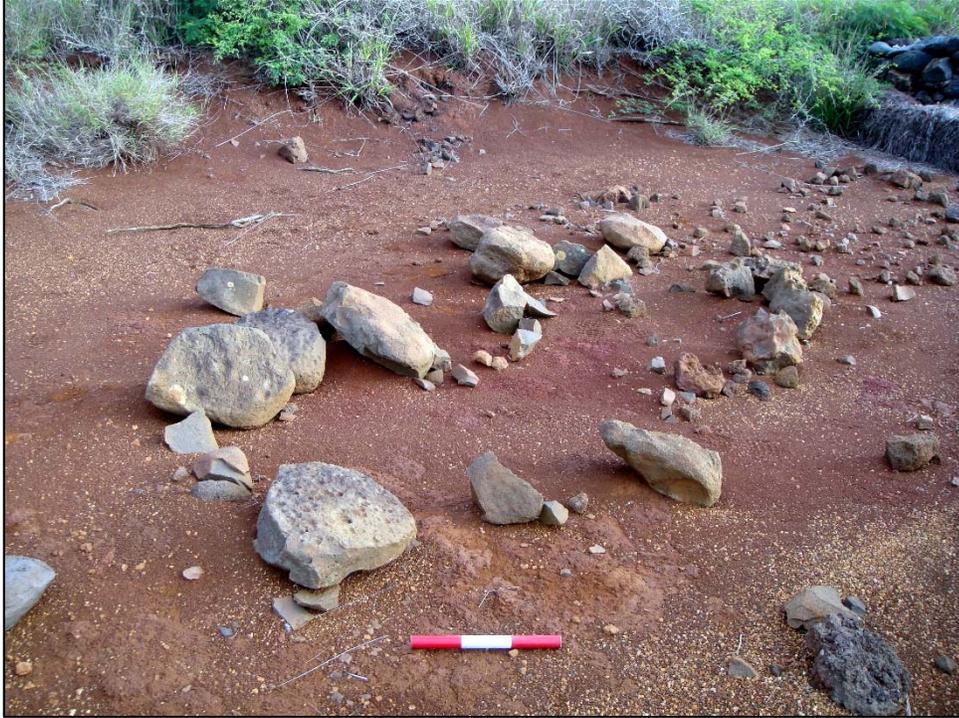
Figure 17. Possible new feature of Site 473, facing northeast. The fire feature is on the side of the hummock in the background.

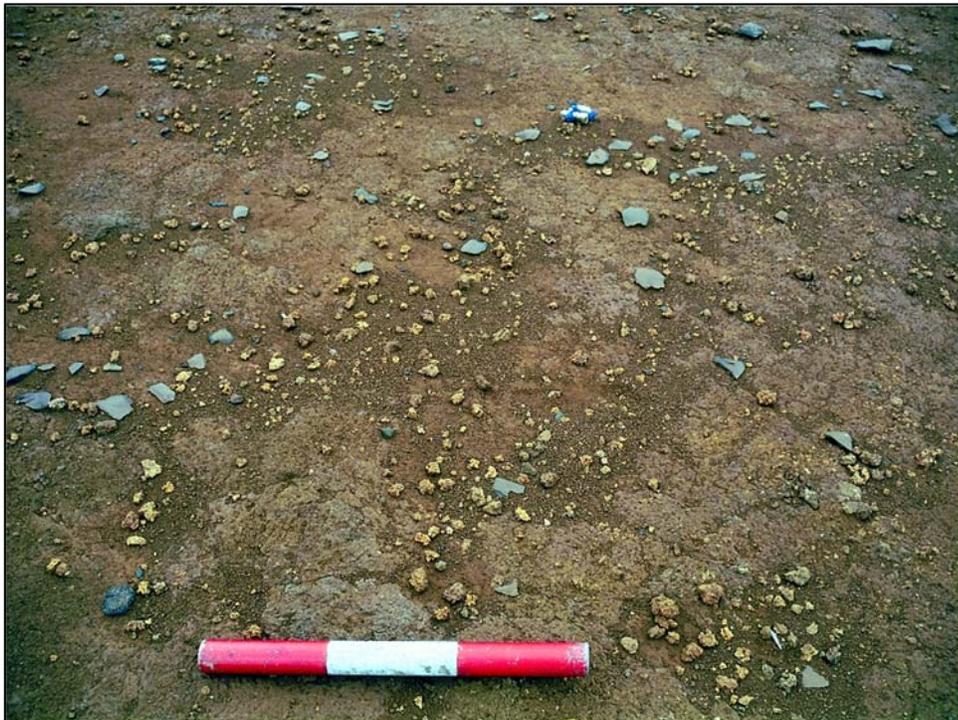
Figure 24. Feature 525B surface scatter, facing south. The coral abrader is wrapped in blue flagging tape in the background.

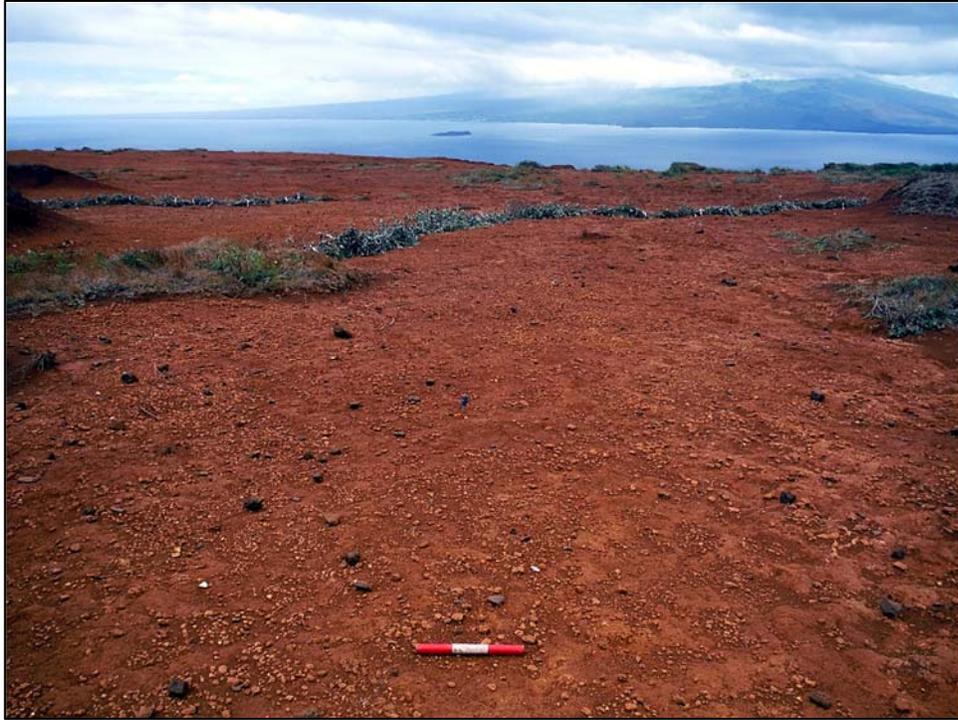
Figure 27. Vegetation bundles with the limits of Feature 525B. View is to the northeast.

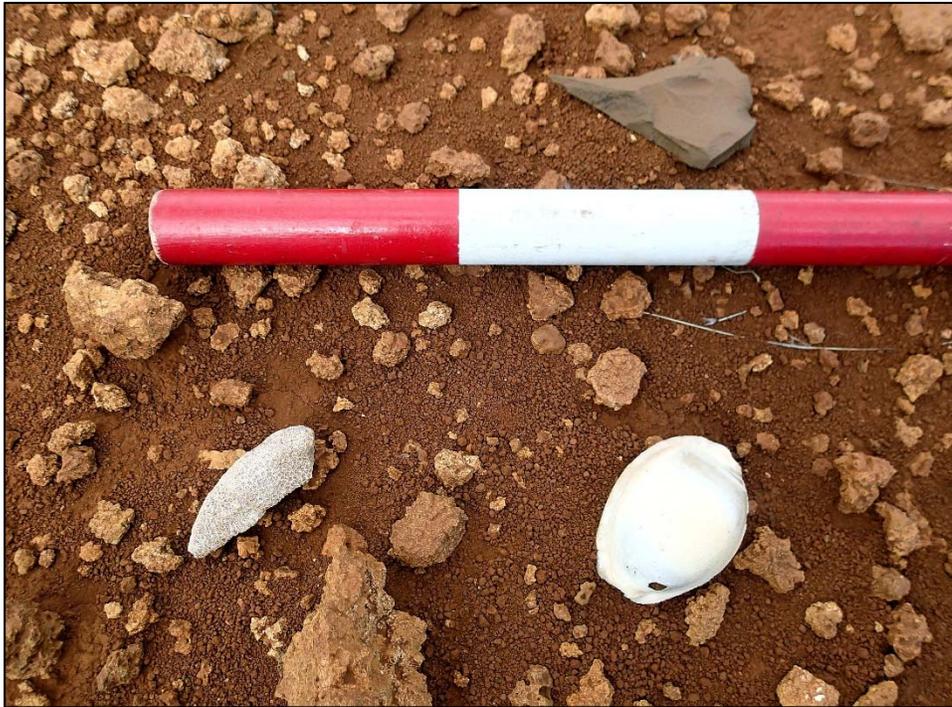
Figure 28. Various cultural material at Site 526, plan view.

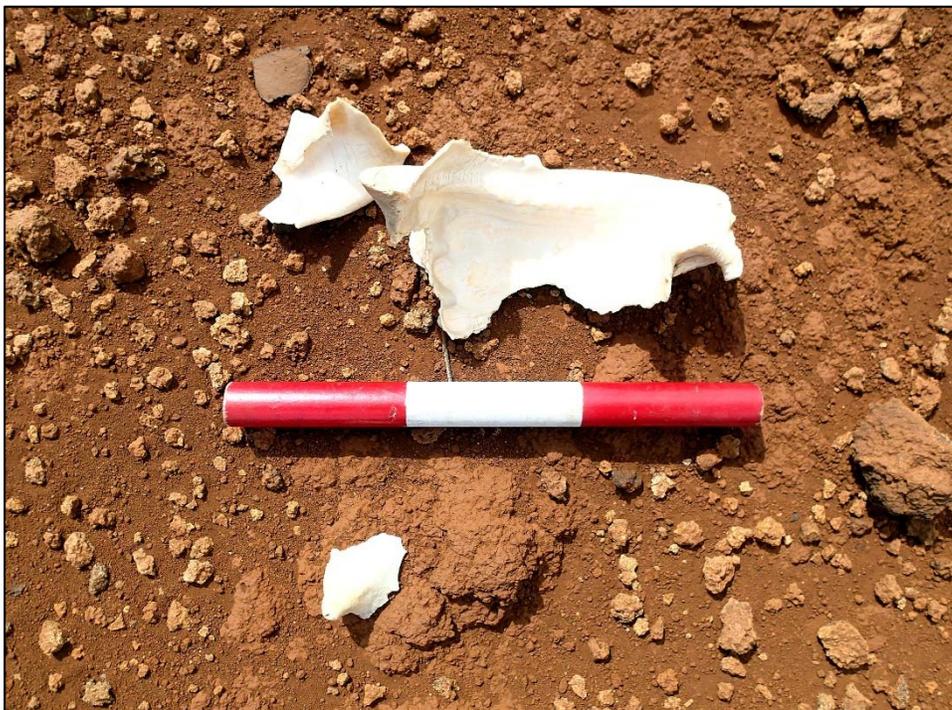
Figure 29. Conch fragment at Site 526, plan view.

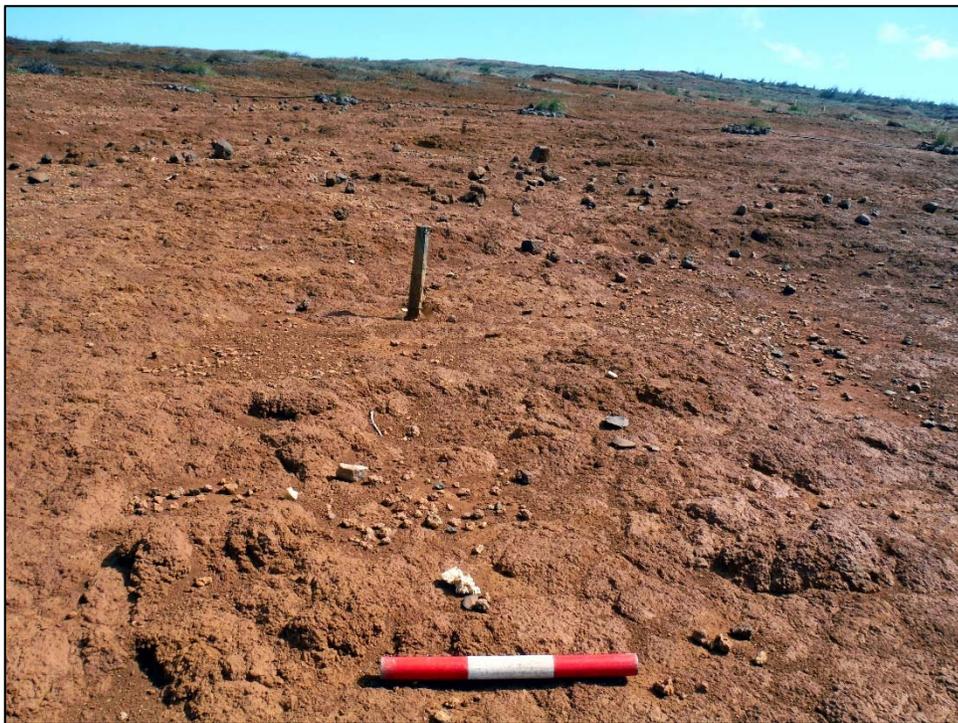
Figure 31. Site 527, facing south. Note artifacts in the foreground and the irrigation line with planting mounds in the distance, stopping outside the site boundaries.

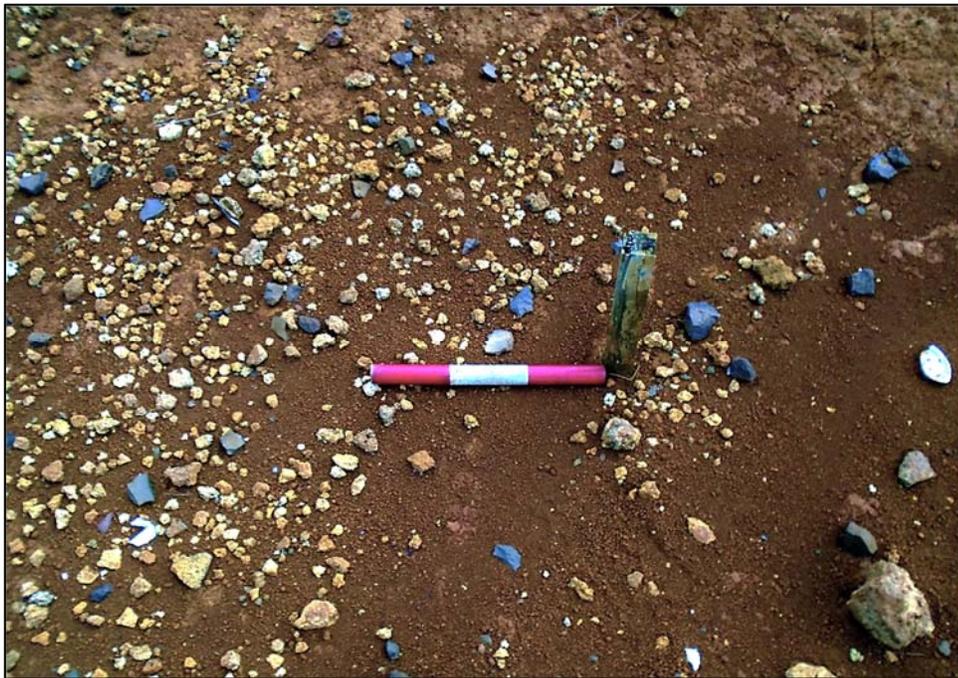
Site 795 is a scatter of artifacts, fractured basalt, basalt flakes and cores, volcanic glass flakes and cores, and shell midden. The site is still a relatively dense cultural material scatter (Figure 43). Most of the site is within the boundaries of a prior undertaking, and irrigation lines from that undertaking run through it. The current undertaking is not impacting the site.

Figure 43. Site 795, facing south.

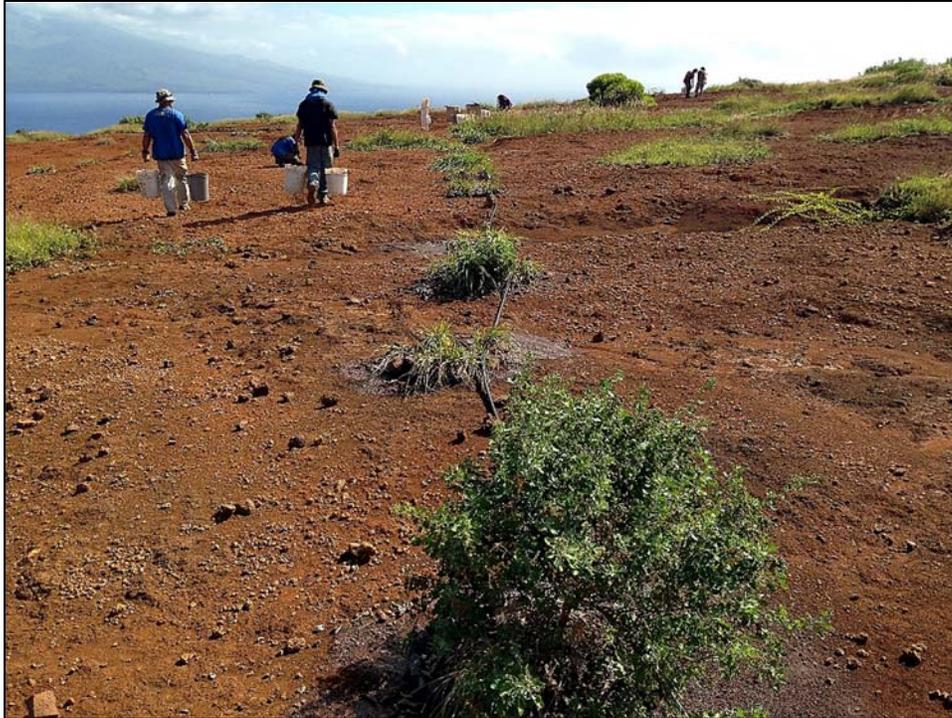
Site 887 is a scatter of artifacts, fractured rock, basalt flakes and cores, volcanic glass flakes, coral fragments, shell midden, and a waterworn pebble. There is currently a low density of cultural material at the site. Revegetation activity took place during the November 2014 site visit and was monitored by the archaeologist. The site was not impacted, and volunteers stayed outside the site's boundaries (Figure 44).

Figure 44. Volunteers working near Site 887 and staying clear of the site. Orientation is to the east.
